Civil Engineering History: Relevant Successes and Failures

A Comparison of Structural Design Aspects of Rana Plaza and the Philadelphia City Hall

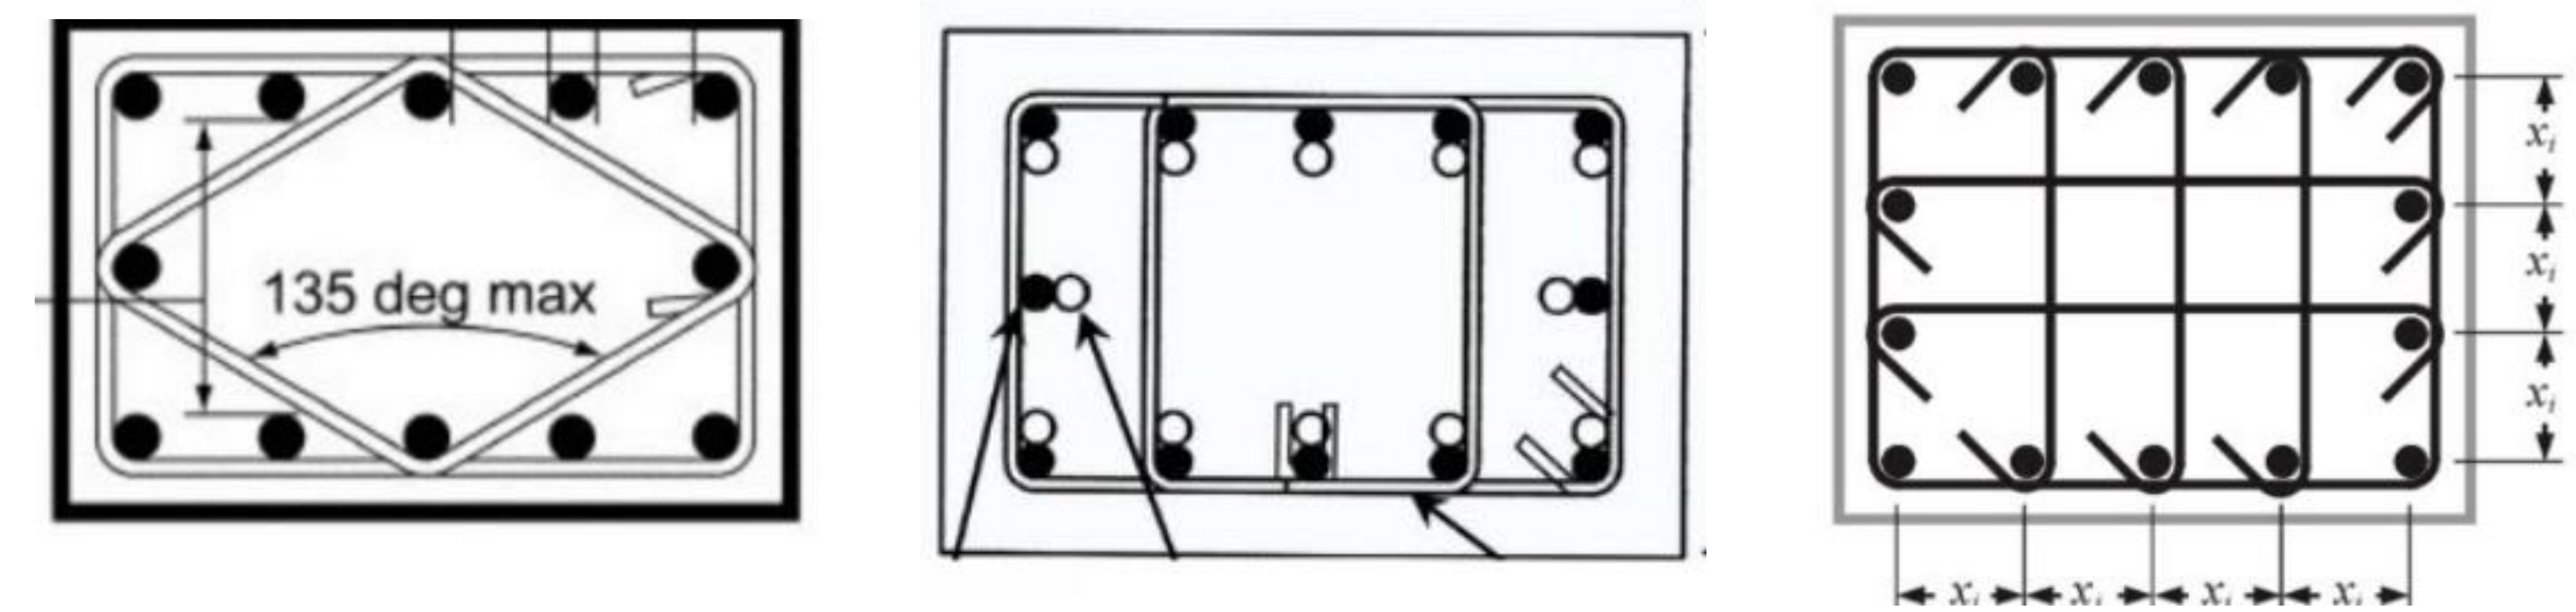
- columns, floors, and foundation all had concrete poured in-situ
- no protection from external loads

- lateral movement was allowed in column attachment and reinforced in iron frame

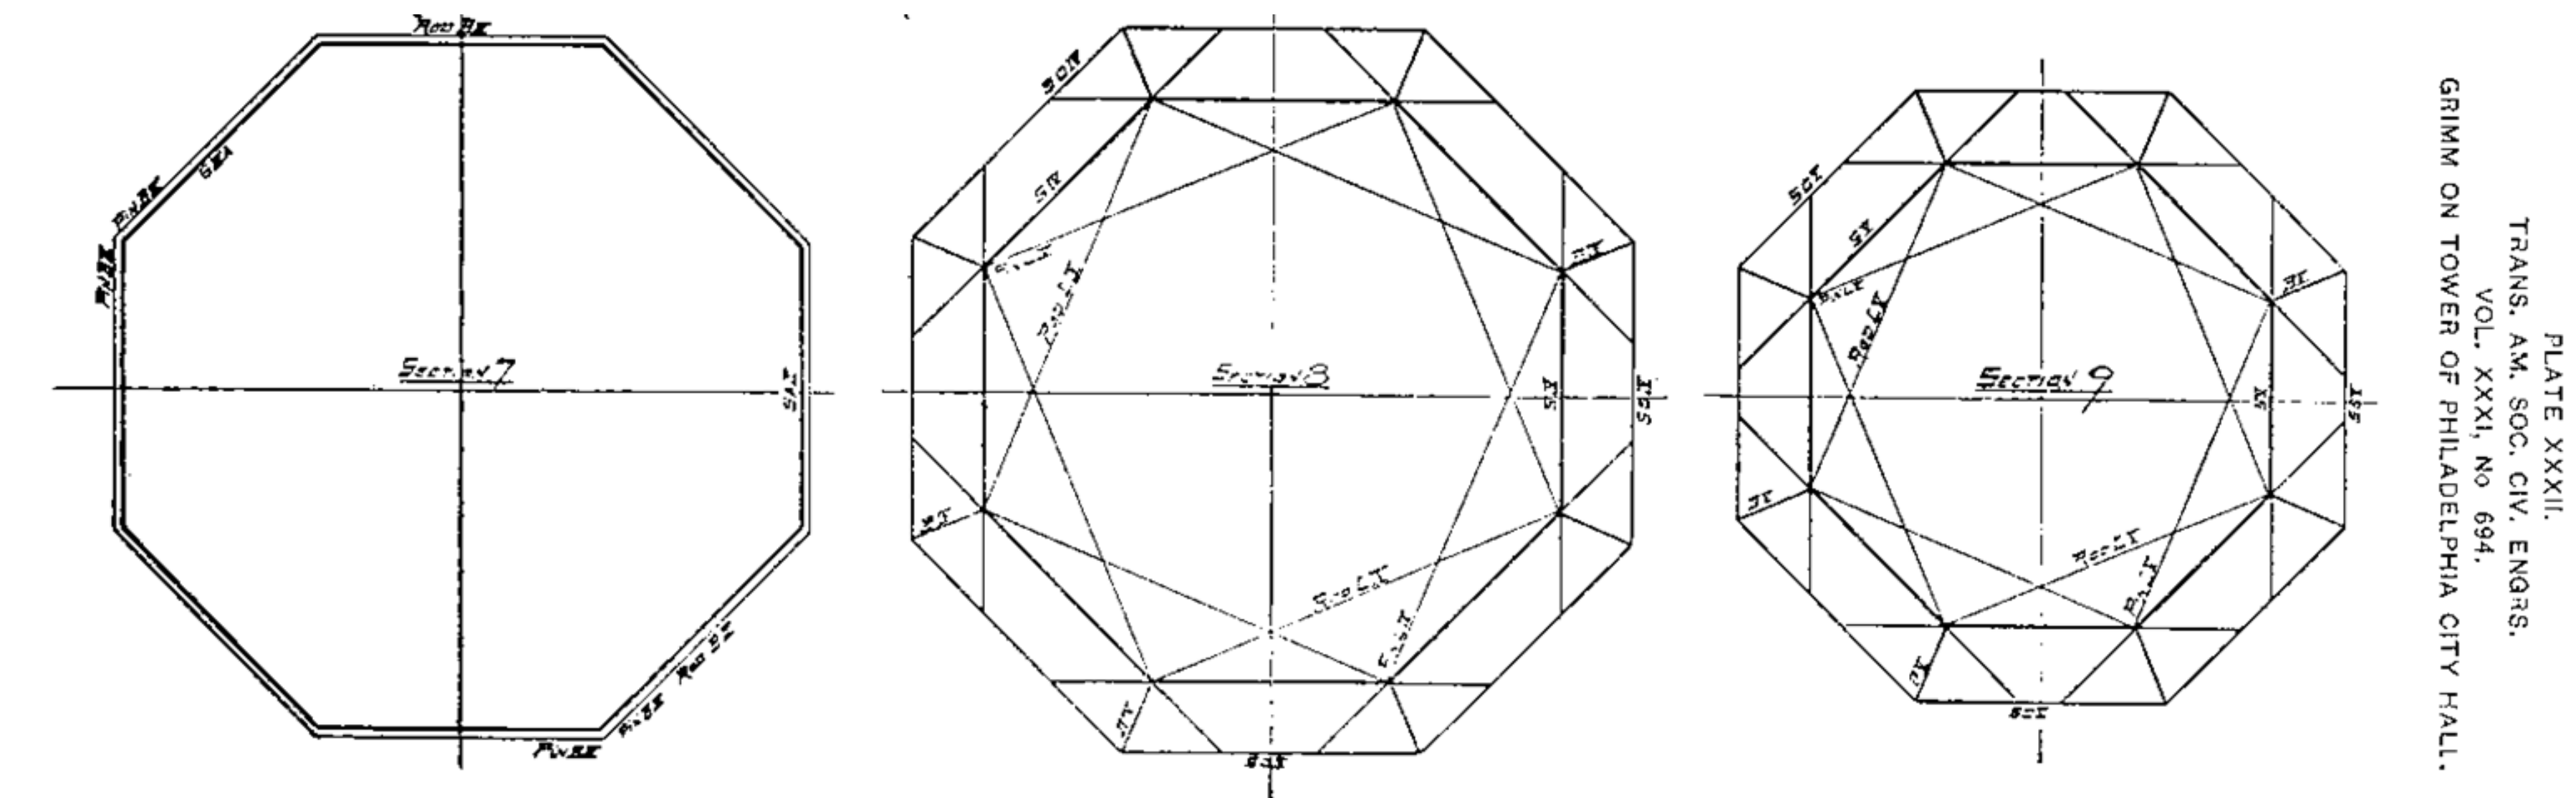
Rana Plaza	Eight stories	Rigid connections	No lateral reinforcement
Philadelphia City Hall	Forty stories	Box girders/anchor bolts	Rings and diagonals

Technical structural differences between column-to-foundation attachments and direction of steel reinforcement determined the fate of these two structures, and the usage of box girders and steel rings could have been applied to prevent Rana Plaza's collapse. This is important in light of the fatalities that occurred.
